TECHNICAL SUMMARY

Designing Pedestrian Safety Features for Year-Round Maintenance

This Technical Summary pertains to Report 2023-18, “Designing and Implementing Maintainable Pedestrian Safety Countermeasures,” published June 2023. More information is available at mdl.mndot.gov.

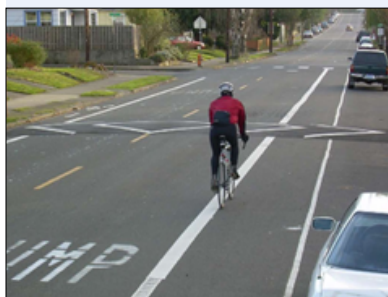
Safety treatments such as speed bumps or curb extensions can be difficult to plow, sometimes resulting in concrete or asphalt damage.

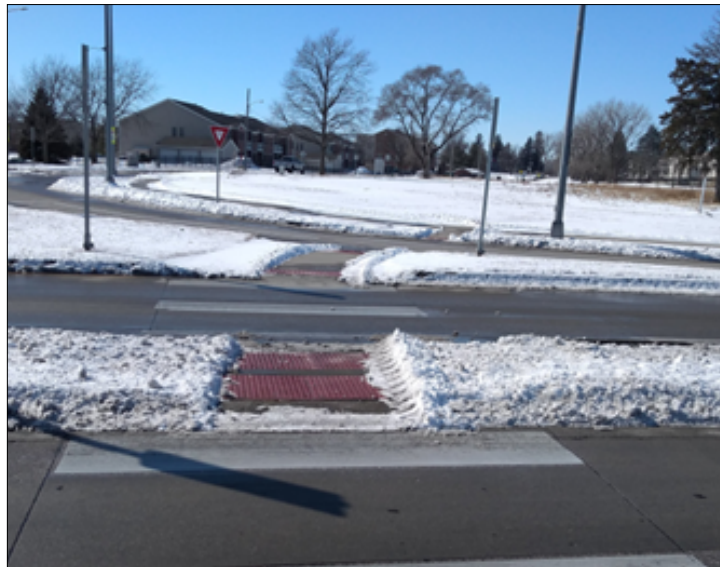
Adequate drainage may be overlooked when pedestrian safety features are designed, such as when a walkway cuts through a median or splitter island and is not sufficiently elevated above the road surface for the water to drain.
